CASE STUDY: AFTERMARKET, AND REMANUFACTURED BUMPERS

SUBJECT: BUMPERS WITH INTEGRATED RAW PLASTIC BLACK OUTS

**CONCERN: AFTERMARKET PRIMERS ARE NOT UV CAPABLE, EXPOSURE TO SUN DEGRADES
PRODUCT RESULTING IN QUALITY CONTROL ISSUES**

SUBJECT CASE 1: 2013 Subaru XV CrossTrek

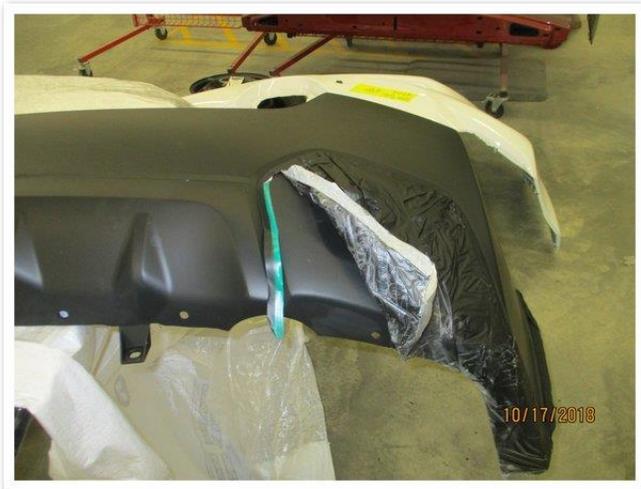
Step 1: Ordered bumper to confirm if the bumper is completely primed as was stated on the phone:

First impressions: The bumper is primed, but they have masked off the raw plastic area to avoid priming it, knowing that the primer is not UV Compliant. However upon further investigation this is not the case.

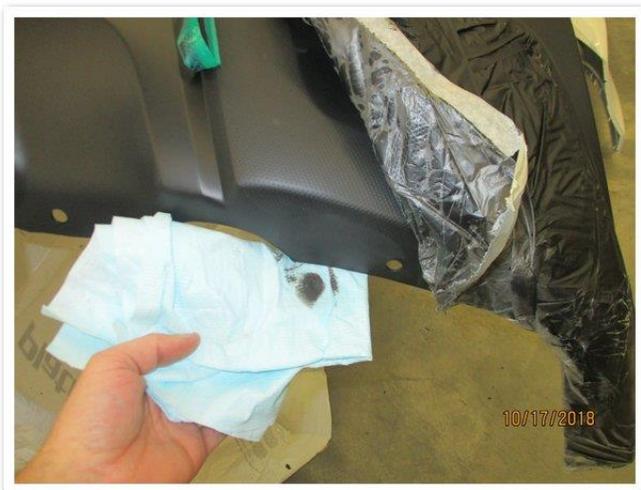
Step 2: Test the part and make sure it is in fact primed, took rag with solvent cleaner on it, and rubbed a bit on the supposedly unprimed portion of the bumper, revealing that there is in fact a solvent primer on the textured area of the bumper.

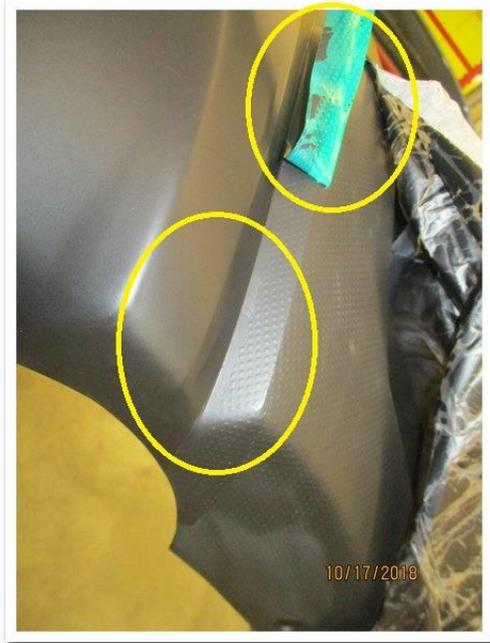
Further proof to this, the tape I pulled back on the textured part peeled some of the primer off the bumper cover

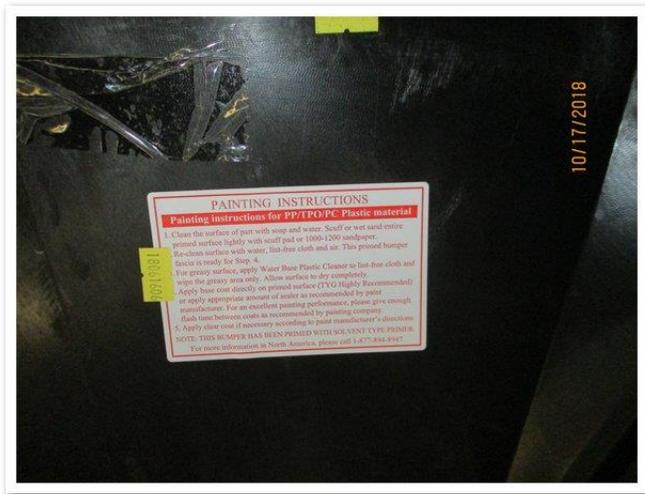
Kyle also mentioned that they are trying to utilize more water base primer as opposed to solvent based primer, this primer definitely cannot be left uncoated.

Conclusion: This bumper does not adhere to OEM quality standards, as this primer will fade over time exposing the poor nature of the primer used over the surfaces that are supposed to be raw plastic. Primer Degradation is to be expected with a product of this nature, it is unacceptable to send a vehicle out with raw primer exposed and call it pre-accident condition, this is an unfit repair.

**SOLUTION: TWO TONE REFINISH TIME OF BUMPERS, OR NEW BUMPER OEM WITH NO LINE
DISCOUNT, WHICHEVER IS MORE COST EFFECTIVE**

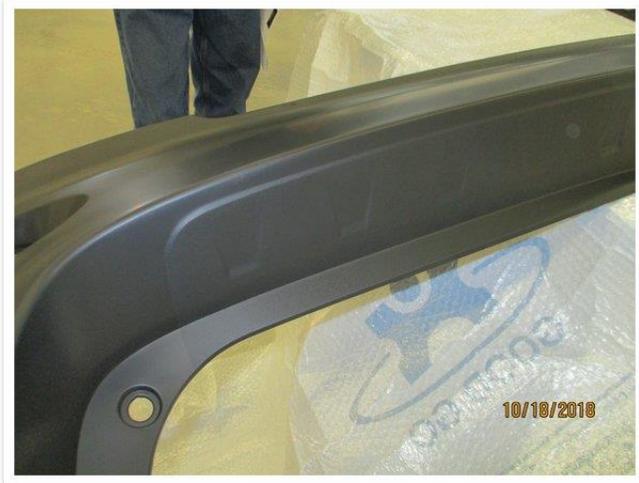
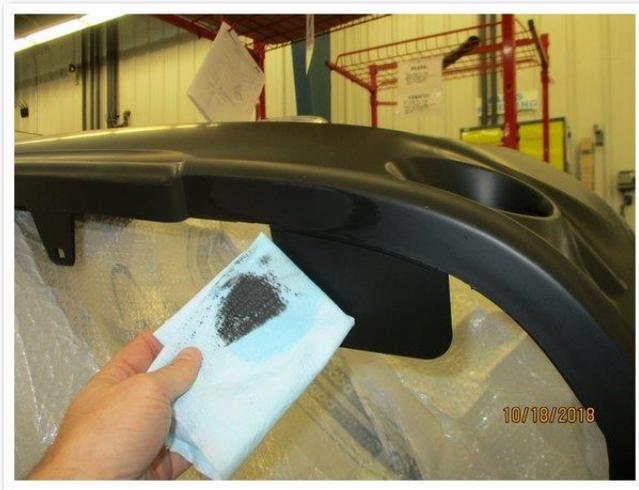
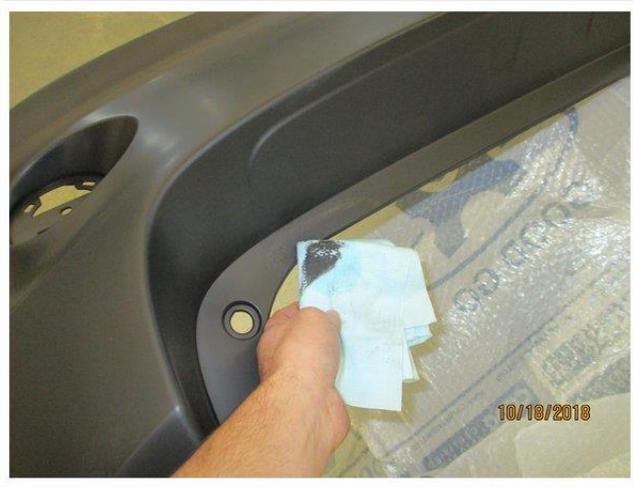
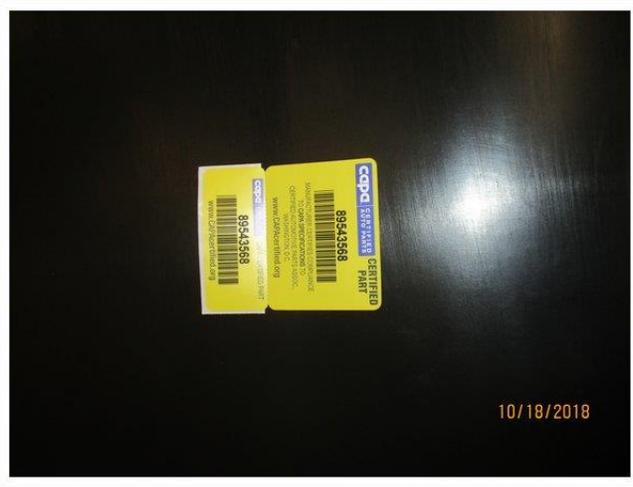
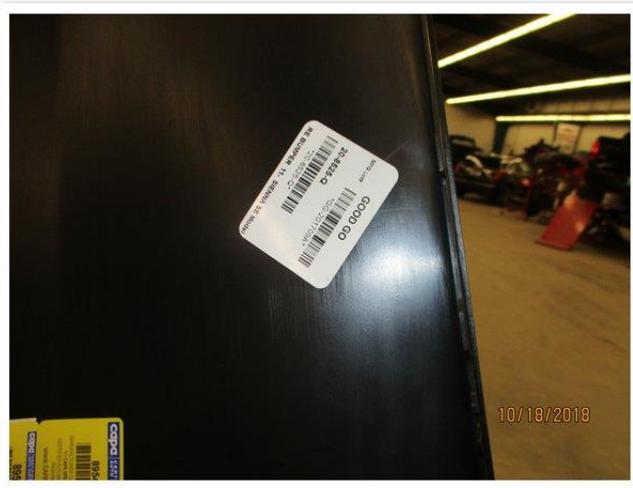
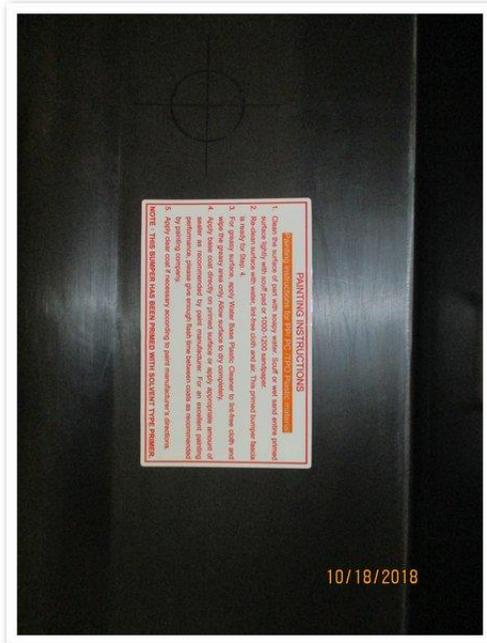
PART # TO1100284C, INV #WP619315, PRO BODY PARTS WINNIPEG.

SAME OUTCOME ON THIS BUMPER, HOWEVER THE STEP PAD AREA WAS NEVER EVEN MASKED OFF, JUST PRIMED RIGHT OVER.
